Manhole Inspection Summary

Manhole # S23I__042MH

Location Address: **1416-1414 S Morris**

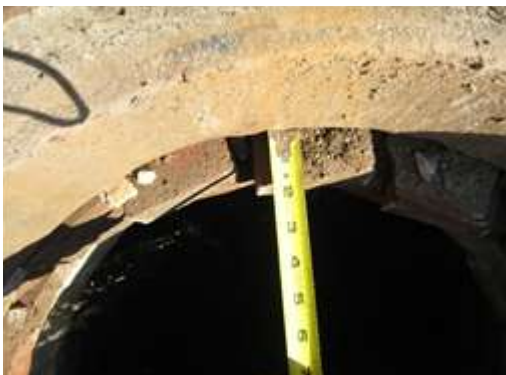
Defect 5

Frame Offset: **1.5** (in.) Condition: ☐ Sound ☐ Cracked ☒ **Leaks**

1.5 inch offset

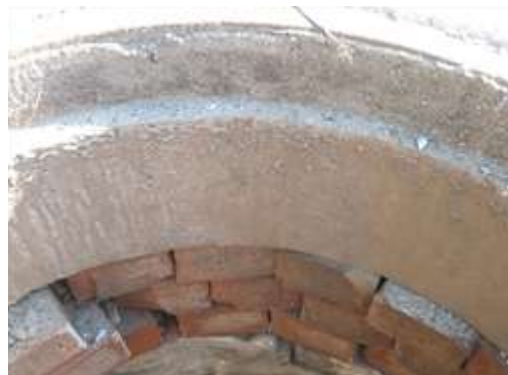
Defect 4

Infiltration: ☐ None ☐ Joint ☐ Cracks ☒ **Mortar** ☐ Roots ☐ Wall

chimney-frame infiltration

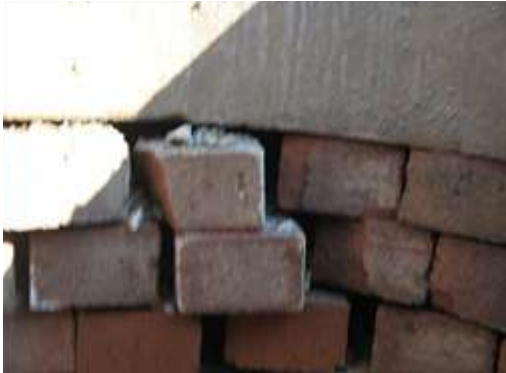
Defect 3

missing mortar chimney

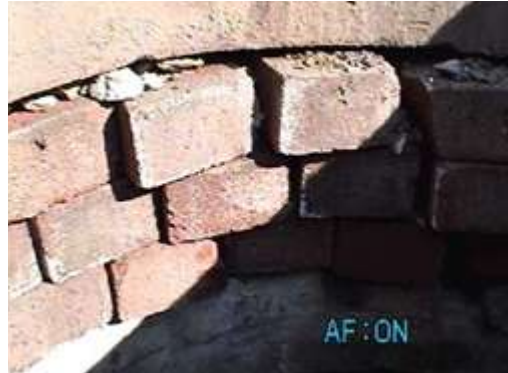
Defect 2

Condition: ☐ Sound ☐ Cracked ☐ Root Intrusion ☒ **Loose Brick** ☐ Deteriorated

Loose Bricks in chimney

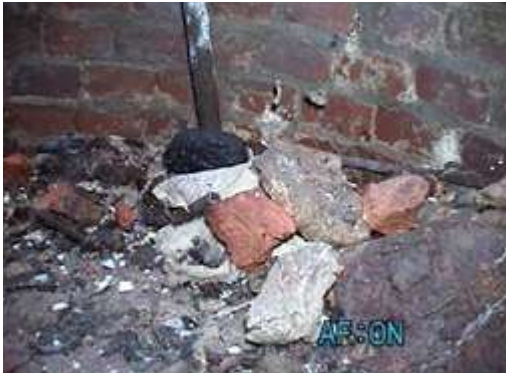
Defect 1

Condition: ☐ Sound ☐ Cracked ☐ Root Intrusion ☐ Deteriorated ☐ Leaks ☒ **Debris**

debris on bench

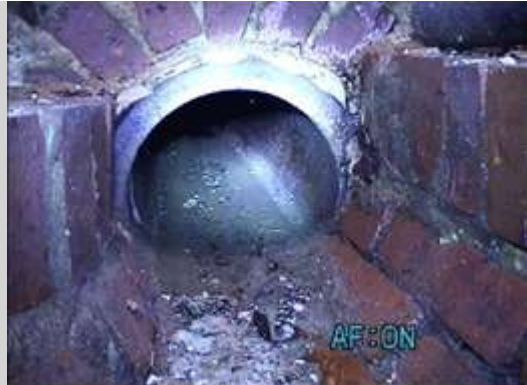
12 O'Clock Outflow

Pipe Height: **8.4** (in.) Rod and Bar (Angled)
Pipe Material: **Clay** ☐ Pipe Lined
Invert Depth: **9.15** (ft.) Flow Characteristics: **Slow**
Deposits: ☒ None ☐ Mud ☐ Sludge ☐ Debris ☐ Grease
Silt Depth: **0** (in.) Deposits Extent:
Infiltration: **None** Pipe Seal Cond: **Sound**

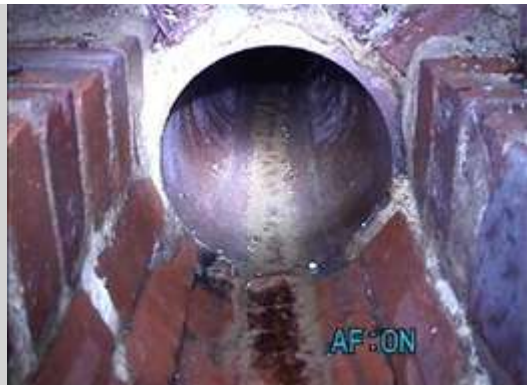
6 O'Clock Inflow

Pipe Height: **8.4** (in.) Rod and Bar (Angled)
Pipe Material: **Clay** ☐ Pipe Lined
Invert Depth: **8.75** (ft.) Flow Characteristics: **Slow**
Deposits: ☒ None ☐ Mud ☐ Sludge ☐ Debris ☐ Grease
Silt Depth: **0** (in.) Deposits Extent:
Infiltration: **None** Pipe Seal Cond: **Sound**

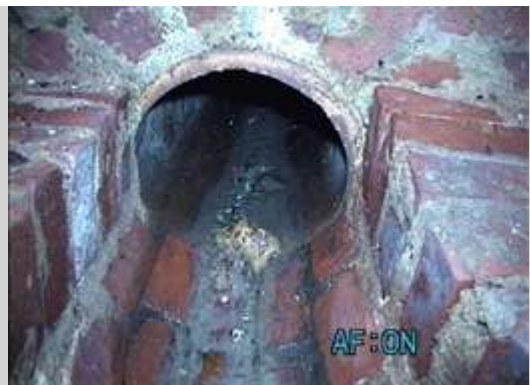
9 O'Clock Inflow

Pipe Height: **8.4** (in.) Rod and Bar (Angled)

Pipe Material: **Clay** ☐ Pipe Lined

Invert Depth: **8.87** (ft.) Flow Characteristics: **Slow**

Deposits: ☒ None ☐ Mud ☐ Sludge ☐ Debris ☐ Grease

Infiltration: **None** Pipe Seal Cond: **Sound**
